TABLE OF CONTENTS

1. INTRODUCTION

former US Steel (USS) site located in Joliet, Illinois.

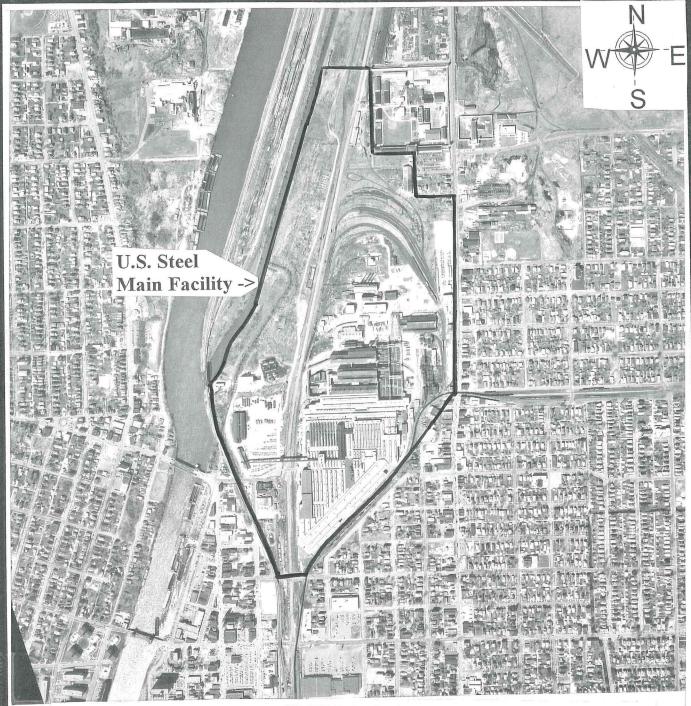
FIGURE 2-4

1976 Aerial Photograph Map

during the 1995 CERCLA sampling event. Figures 2-1 through 2-5 show the former USS property and its surroundings.
